LARGE CALIBER WEAPON SYSTEMS LABORATORY

ENGINEERING REPORT LCR-E-1004

DUD INVESTIGATION OF
M69 ELECTRIC DETONATOR

11 APR 1978

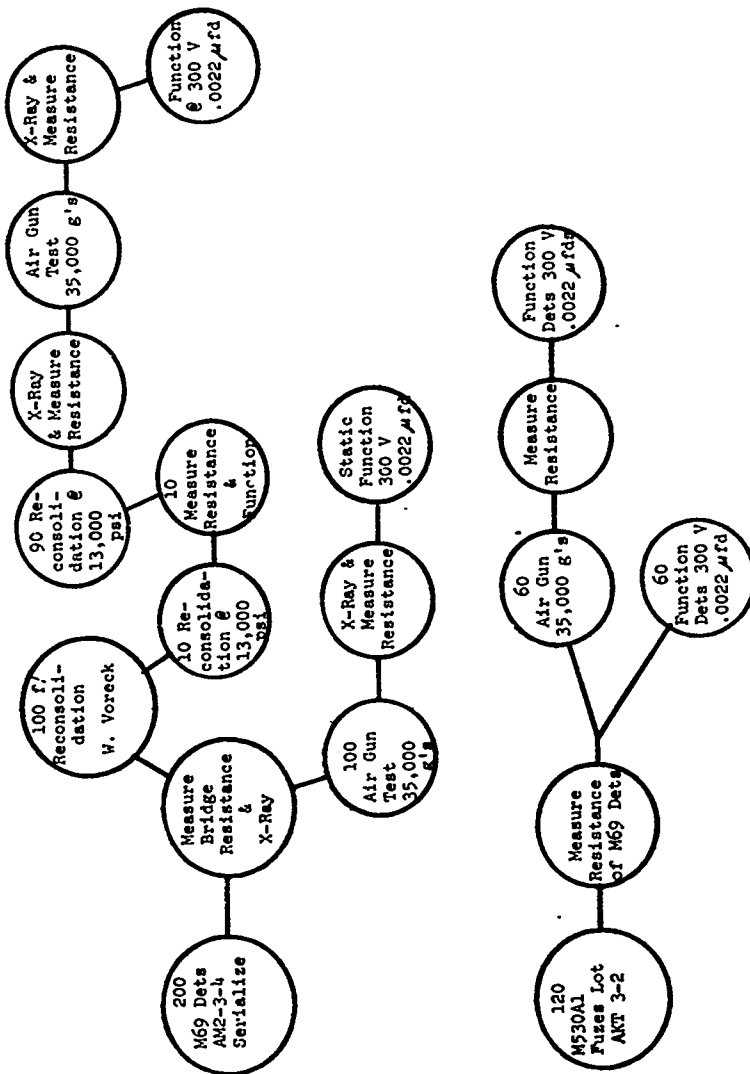
FIGURE 11

Consequently, it was decided that a test program should be outlined to investigate the cause of the duds and evaluate its resolution. Figure 11 represents the test plan implemented. The basic intent of this plan was to evaluate the present M69 Detonator Lot AM2-3-4 with which the problem occurred, an existing supposedly acceptable lot of M69 Detonators as loaded in M530A1 Fuzes and a quantity of Lot AM2-3-4 modified to correct the hypothesized problem.
